Qualitative On-Roof
Infrared Thermographic Survey
of Roof Moisture

at "Building 163"
September 26, 2022

Roof Moisture Infrared Survey of "Building Name" on September 26, 2022

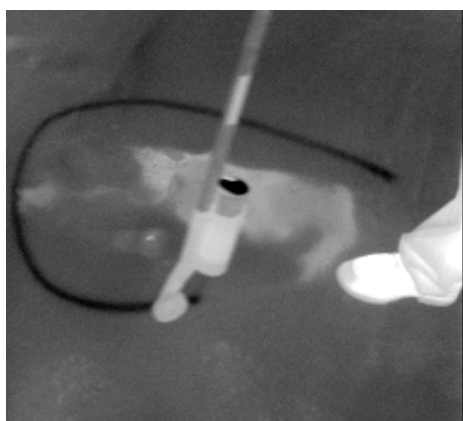
Suspect wet areas marked directly on the roof with marking paint.

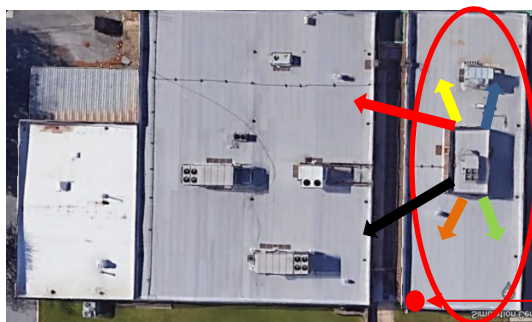
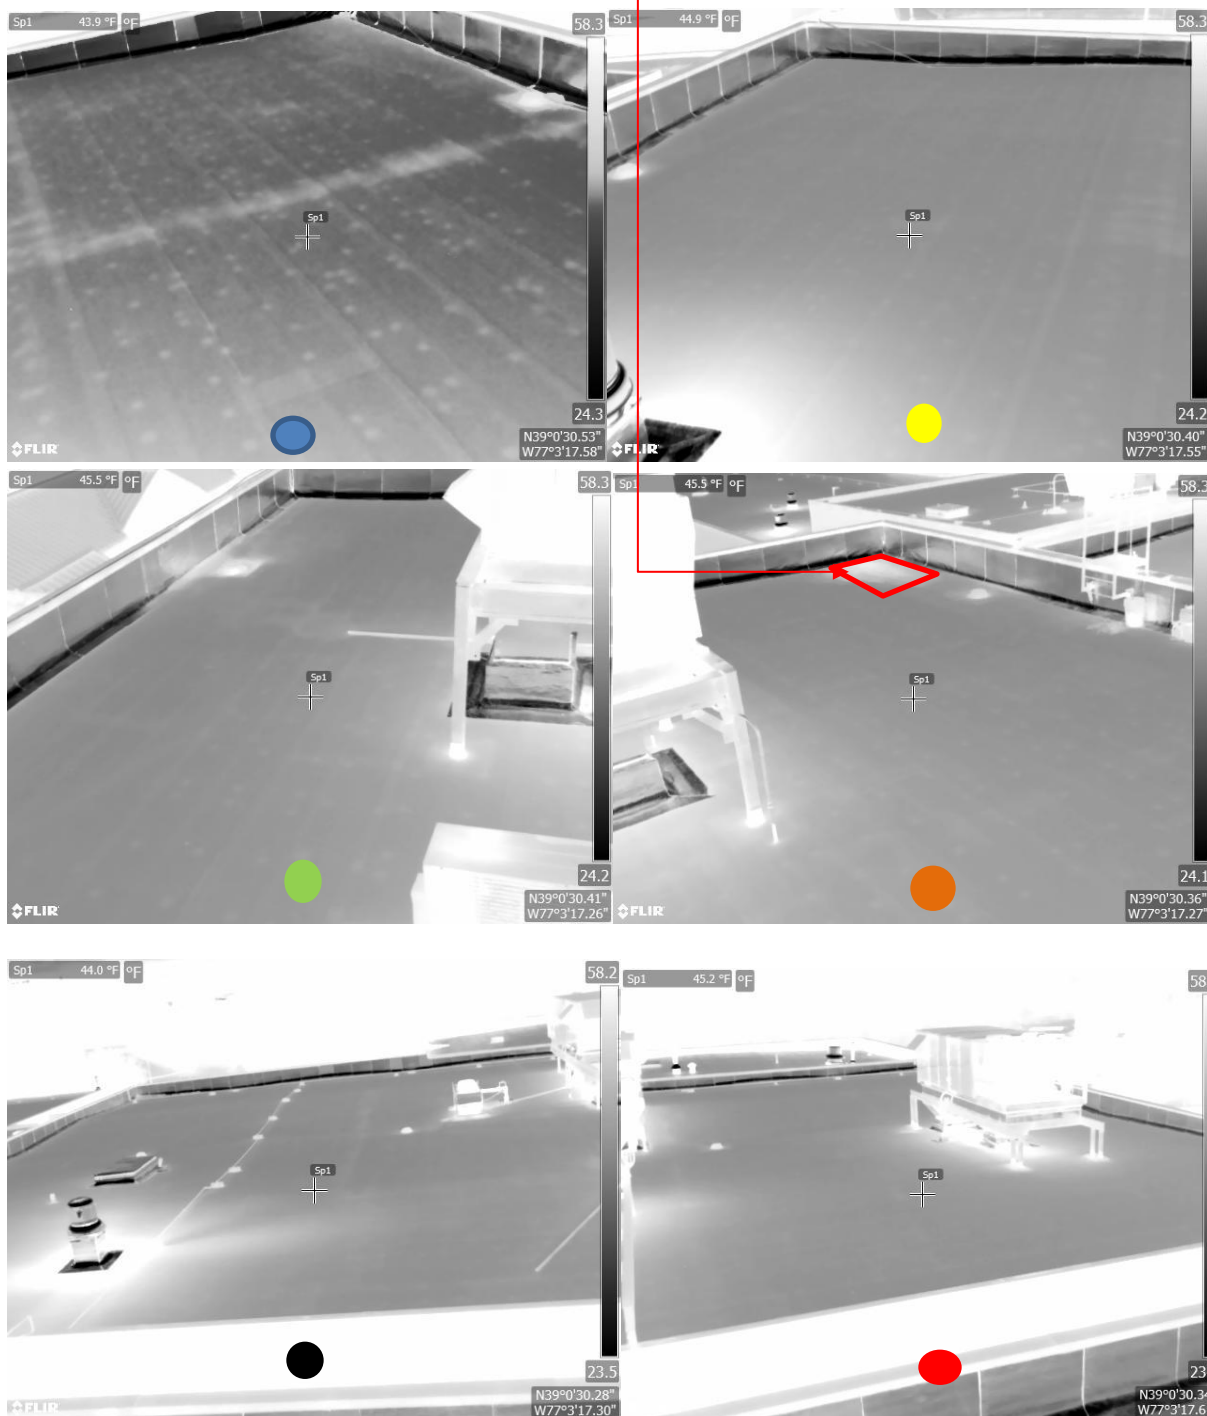
Arrow to roof anomaly

Estimated area to repair and possible leak penetration.

Replacement roof area - @ 26sqft

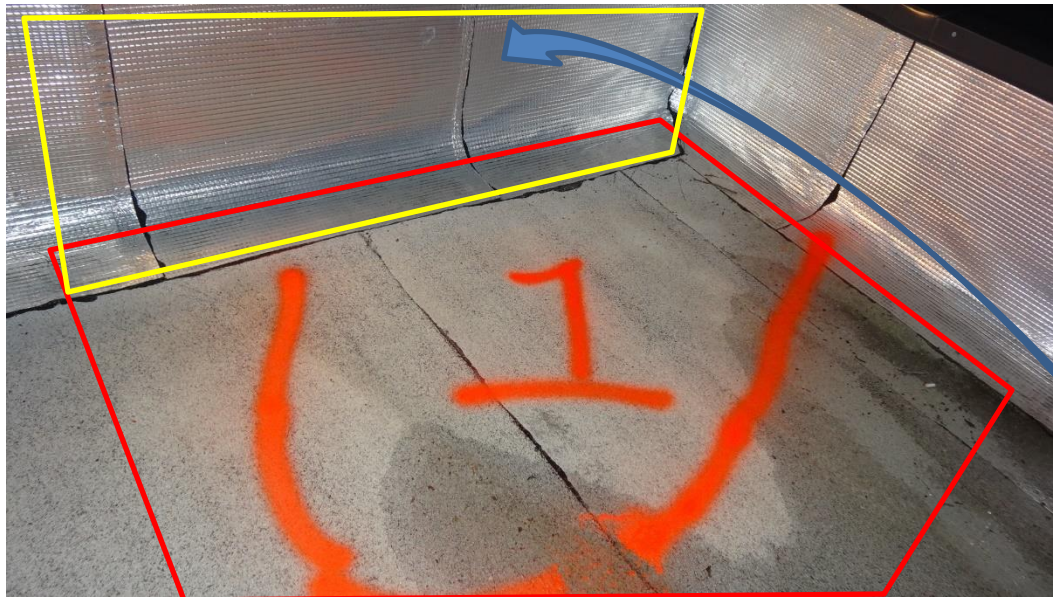
Suspect entry repair location – parapet wall and cap

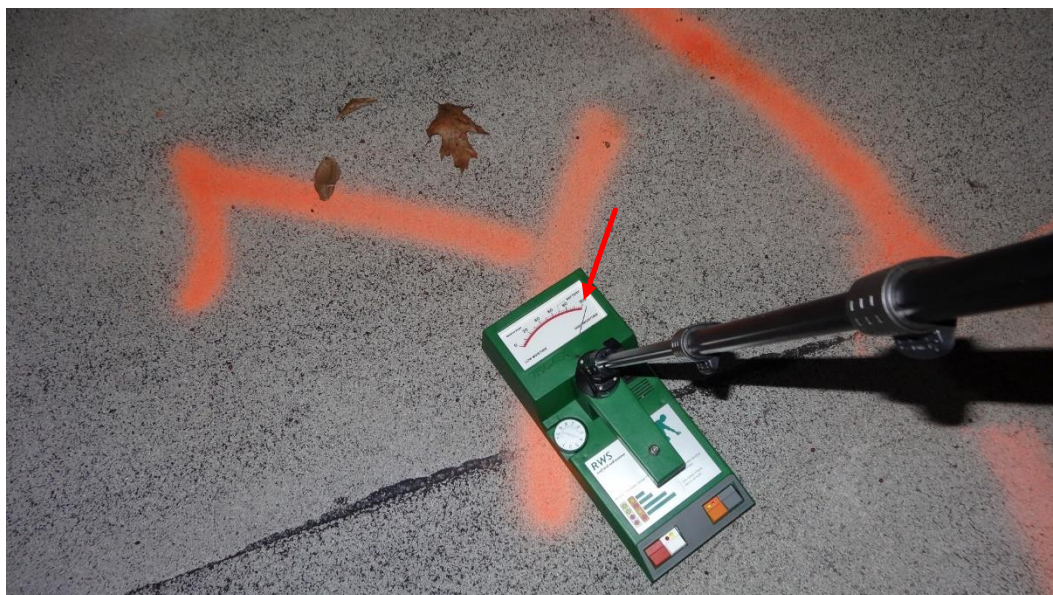
Electronic Verification of water

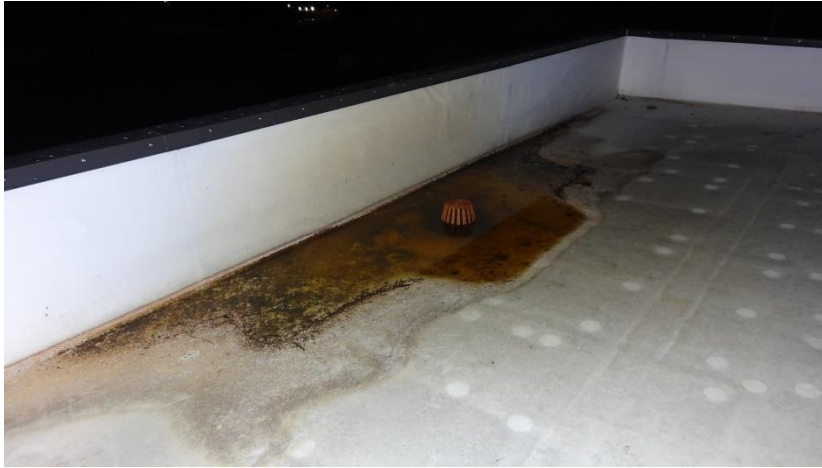
Ponding Water on TPO roof

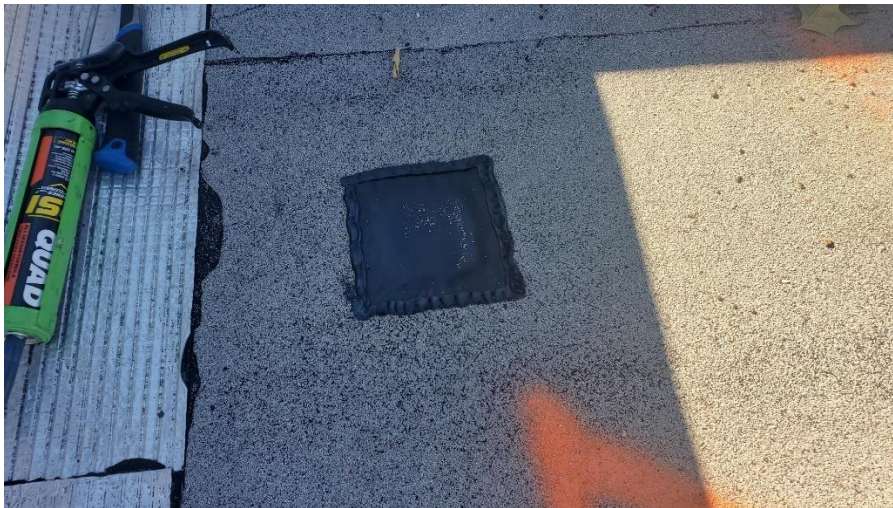
Evidence of Core Sample Repair
