Qualitative On-Roof
Infrared Thermographic Survey
of Roof Moisture

at "Building 163"
September 26, 2022

Roof Moisture Infrared Survey of "Building Name" on September 26, 2022

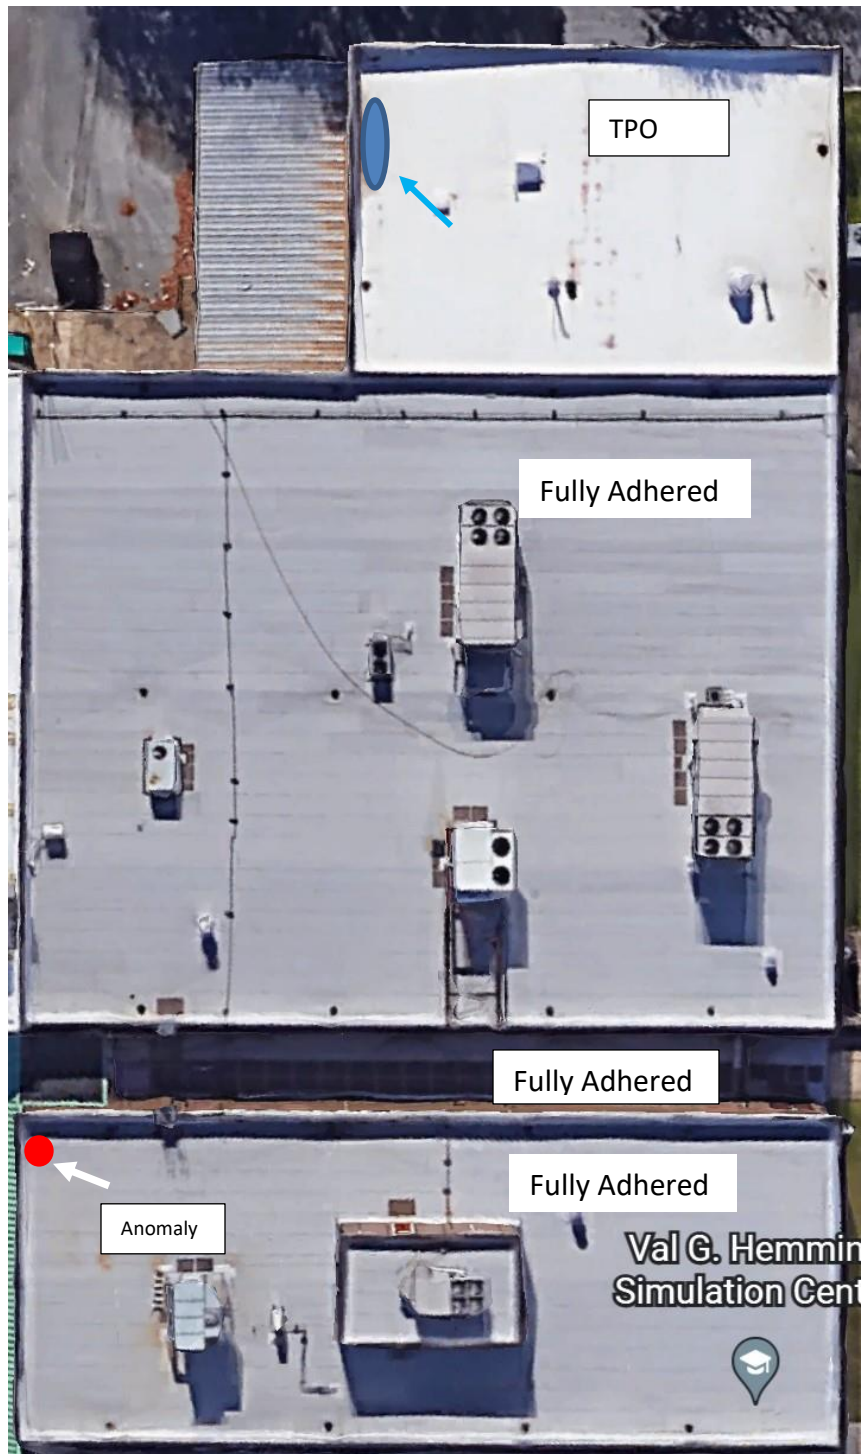
Report #: 1

Notes: Roof core sample recommended here to confirm current moisture

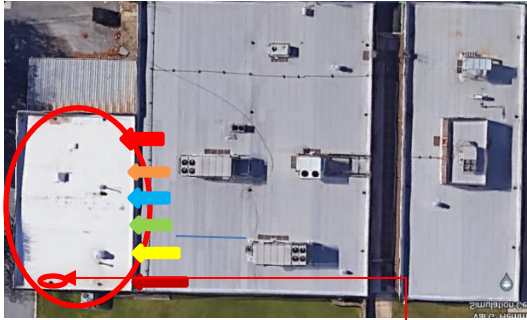
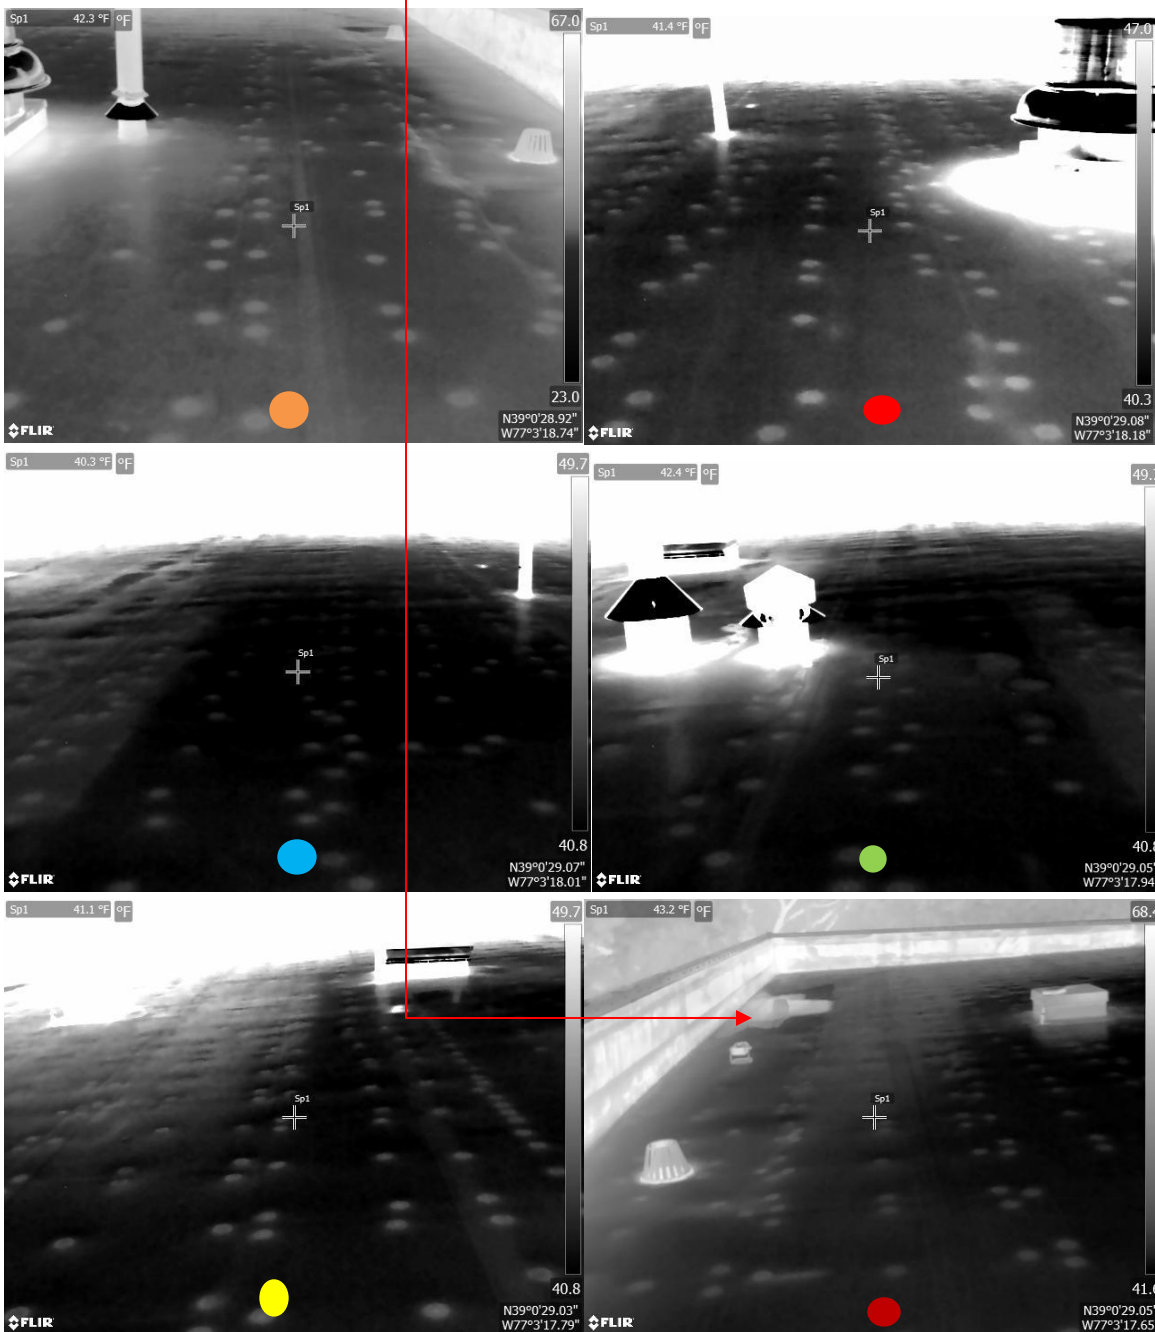
IR By Roof Section (no anomaly)

Match arrow color with aspect and direction of IR to see aspect of picture. Red arrow indicates location of ponding water
